**MARYLAND HISTORICAL TRUST
DETERMINATION OF ELIGIBILITY FORM**

Property Name: Hall of Mount Hope Lodge Number 2 Inventory Number: K-511
Address: 5827 Crosby Road City: Rock Hall Zip Code: 21661
County: Kent USGS Topographic Map: Rock Hall Quad
Owner: Aaron United Methodist Church Is the property being evaluated a district? ☐ yes
Tax Parcel Number: 377 Tax Map Number: 51 Tax Account ID Number: 024471
Project: Rock Hall Proposed Microwave/Radio Tower Agency: Department of Budget and Management
Site visit by MHT Staff: ☒ no ☐ yes Name: _____ Date: _____
Is the property located within a historic district? ☐ yes ☒ no

K-511: Hall of Mount Hope Lodge Number 2

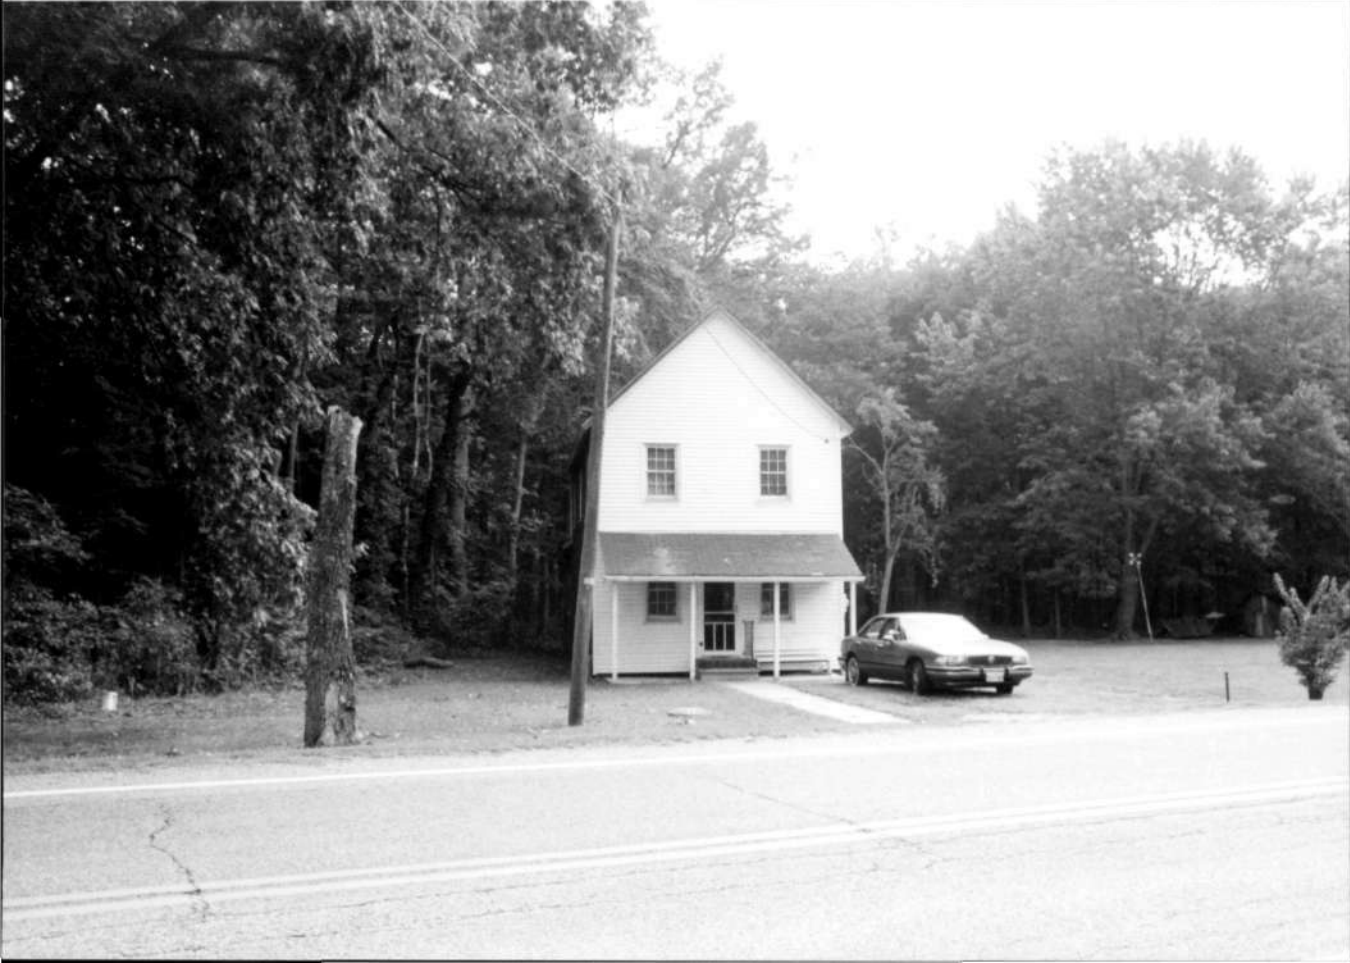
PHOTO 1 of 4

The west (front) elevation is three-bays wide and symmetrical. A central single-leaf, wooden door comprises the main entry. A single, six-over-six, double-hung sash, wooden window occupies each bay to the north and south of the main entry. Two evenly spaced, six-over-six, double-hung sash, wooden windows occupy the second floor. A single-story, shed-roof porch stretches across the entire west elevation. Four evenly spaced, squared, wooden posts support the shed roof which is covered in asphalt shingles. A poured concrete slab comprises the porch floor.

WEST (FRONT) ELEVATION OF LODGE

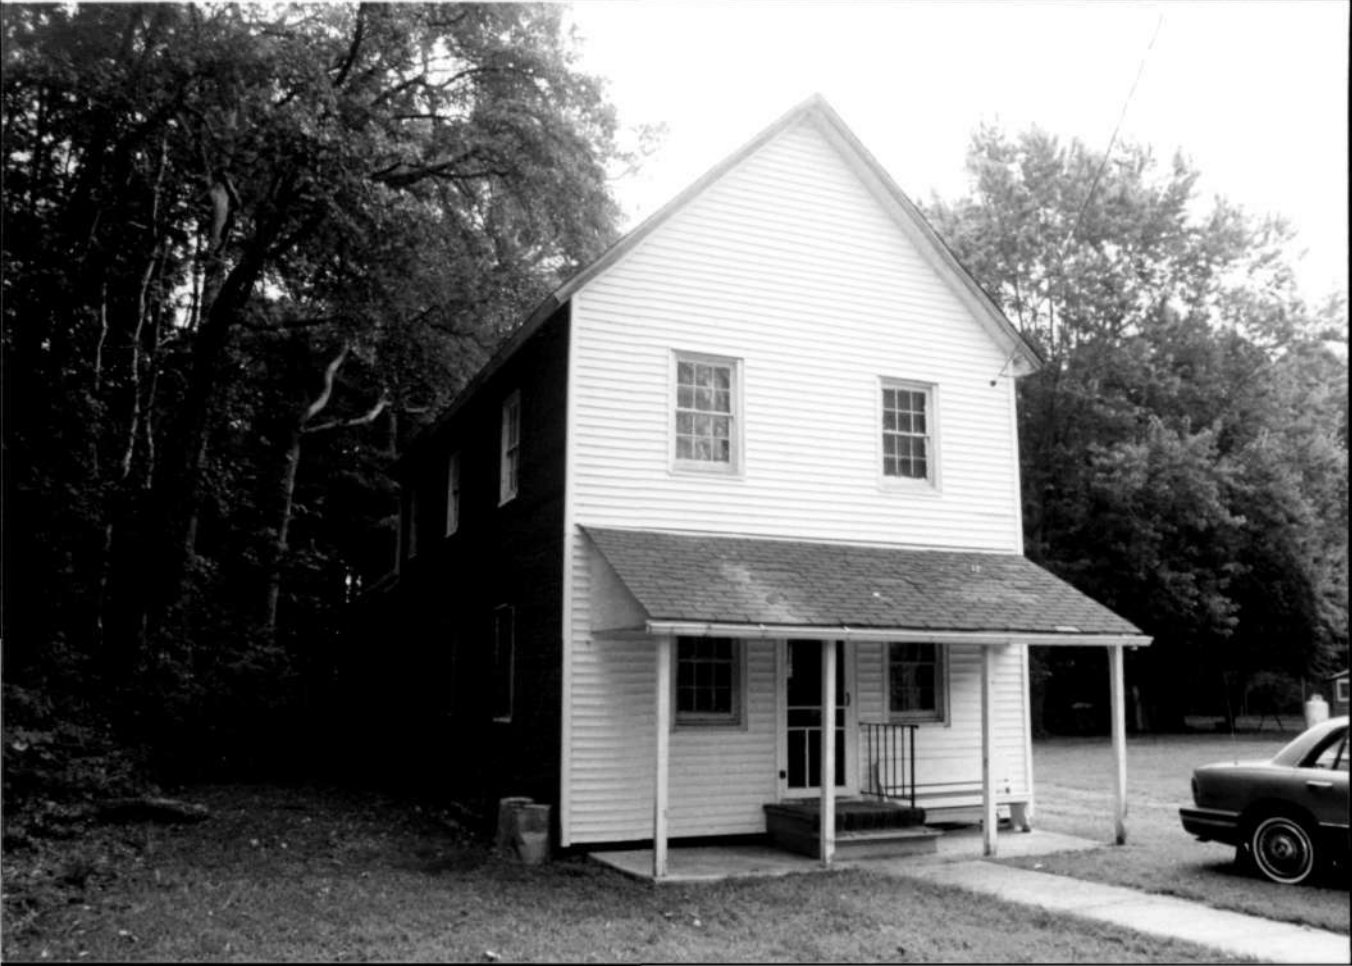
PHOTO 2 OF 4

The north elevation of the main block consists of three evenly spaced bays. The first and second floors each contain three evenly spaced, six-over-six, double-hung sash, wooden windows. The north elevation of the rear kitchen addition contains three evenly spaced bays consisting of six-over-six, double-hung sash, wooden windows.

WEST (FRONT) & NORTH ELEVATIONS OF LODGE

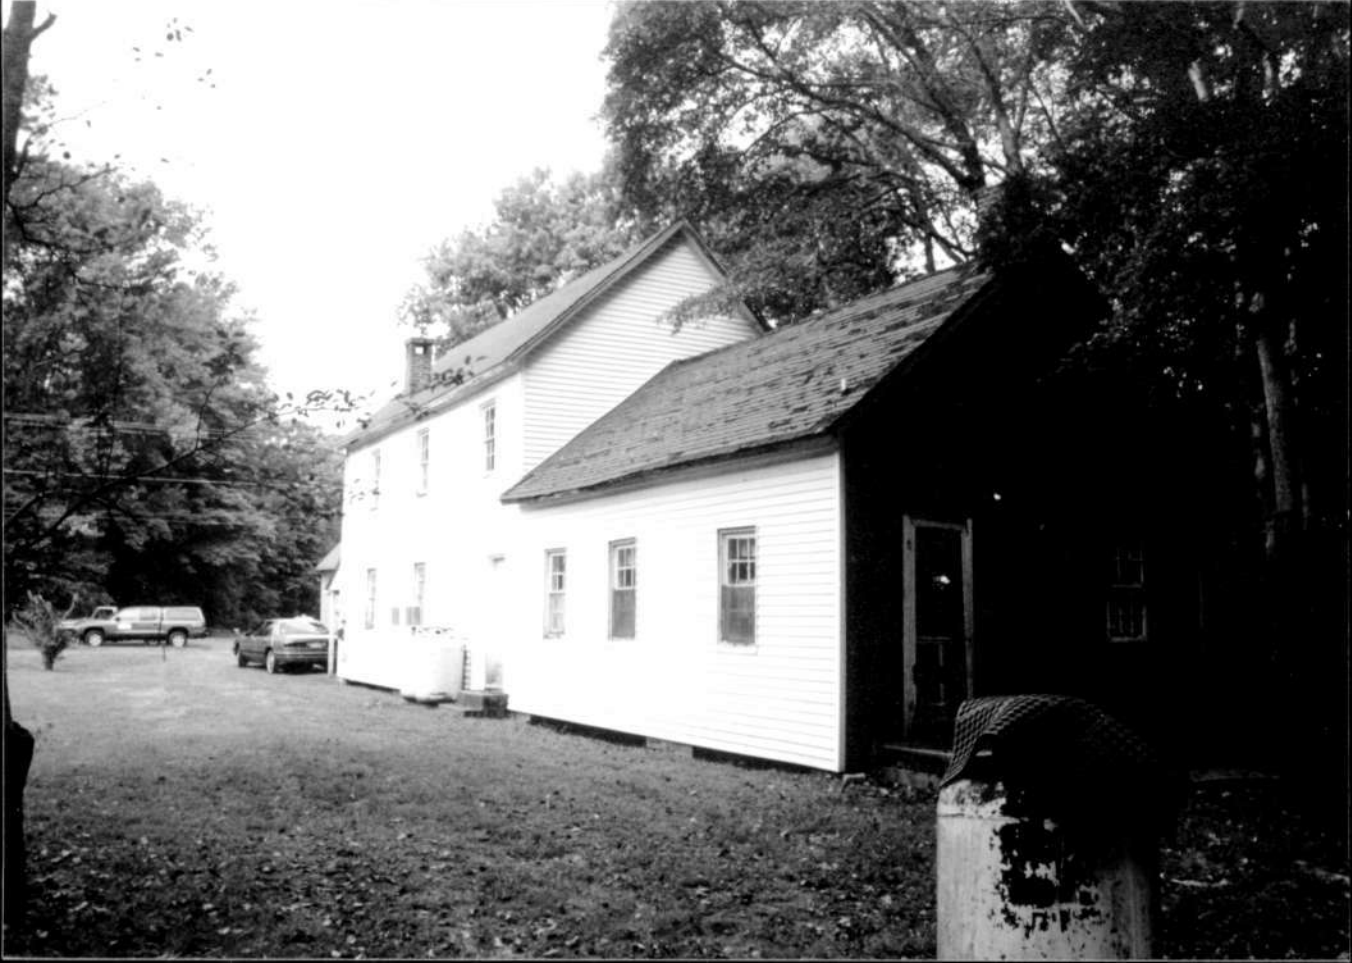
PHOTO 3 of 4

The first and second floors of the east elevation of the main block are concealed by the gable roof of the single-story, rear kitchen addition. Therefore, no openings are visible on the east elevation of the main block. The east elevation of the rear addition contains two evenly spaced bays. The southernmost bay consists of the rear entrance, which is comprised of a single-leaf wooden door. The northernmost bay contains a six-over-six, double-hung sash, wooden window. A brick, interior chimney divides the two bays and protrudes from the gable end of the rear addition.

EAST (REAR) ELEVATION & SOUTH ELEVATION OF LODGE

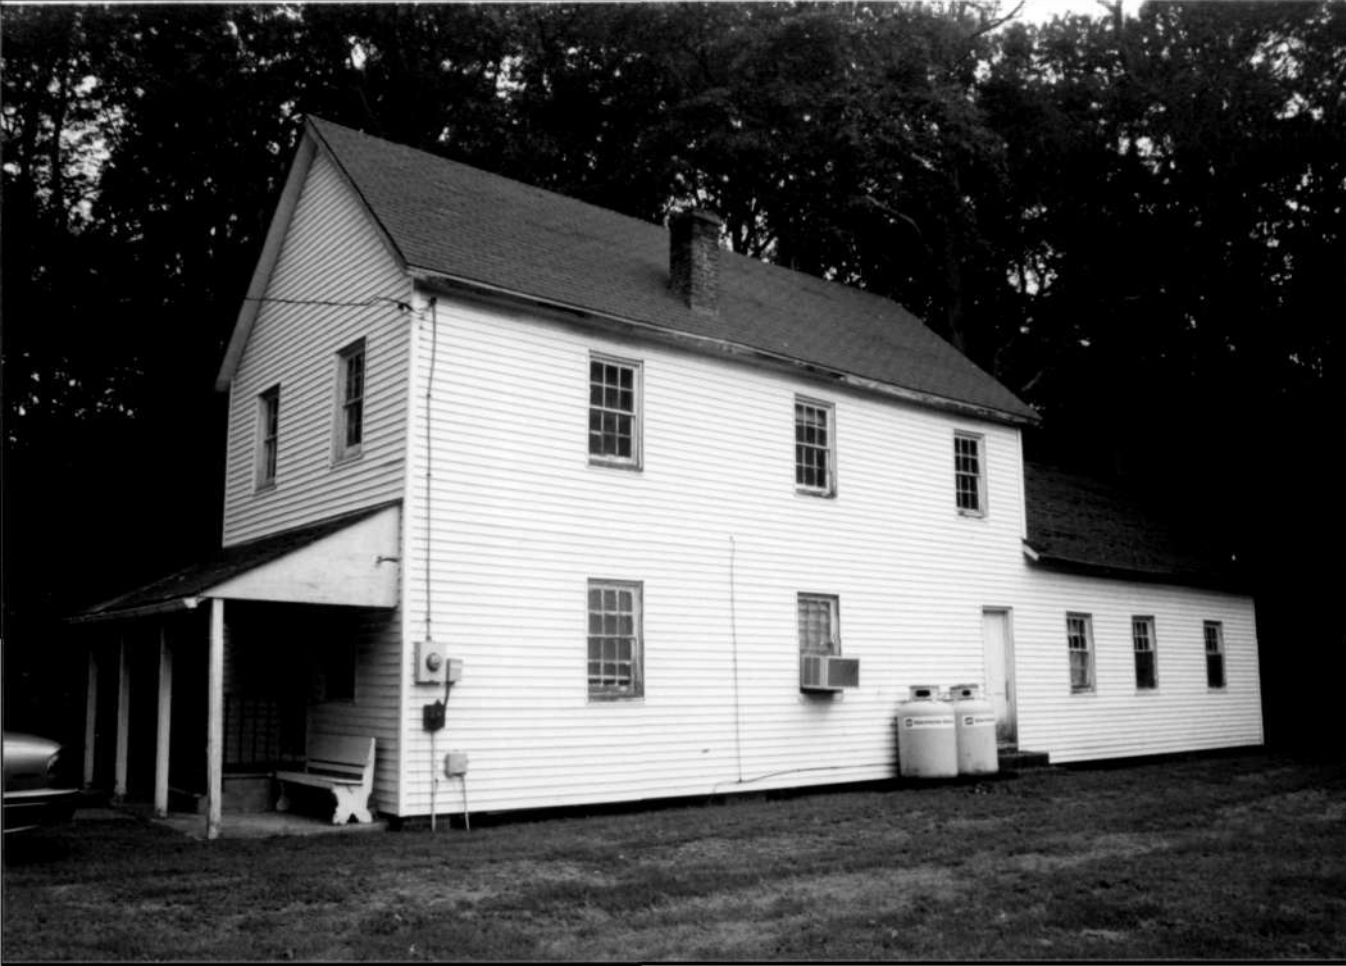
PHOTO 4 of 4

The main block of the south elevation contains three evenly spaced bays. The two westernmost bays of the first floor contain a single, six-over-six, double-hung sash, wooden window. The easternmost bay contains a secondary entrance consisting of a modern single-leaf aluminum door. A brick, interior chimney bisects the two westernmost bays. Three evenly spaced, six-over-six, double-hung sash, wooden windows make up the south elevation of the rear kitchen addition.

SOUTH ELEVATION OF LODGE
